Turitea wind farm Community Liaison Group

4 May 2022

PROJECT UPDATE

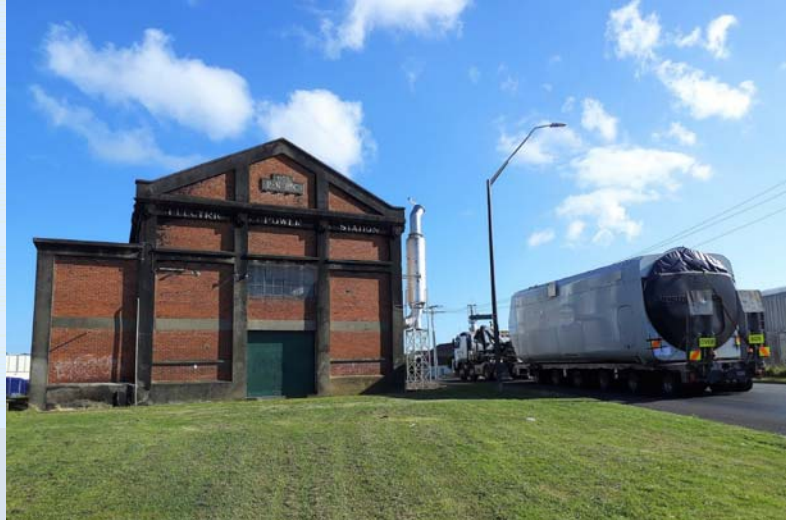
3

Glen shared this slide showing a nacelle (the top part of the turbine that the blades attach to) being trucked past a relic of past power generation and distribution in the district.

In February replacement nacelles and hubs at were unloaded at Napier port, replacing those lost in the December 2020 ship fire. They were taken to Hastings then reloaded for transport to Palmerston North. All major components for the rest of the build are now in the country, ready for the final trip to site.

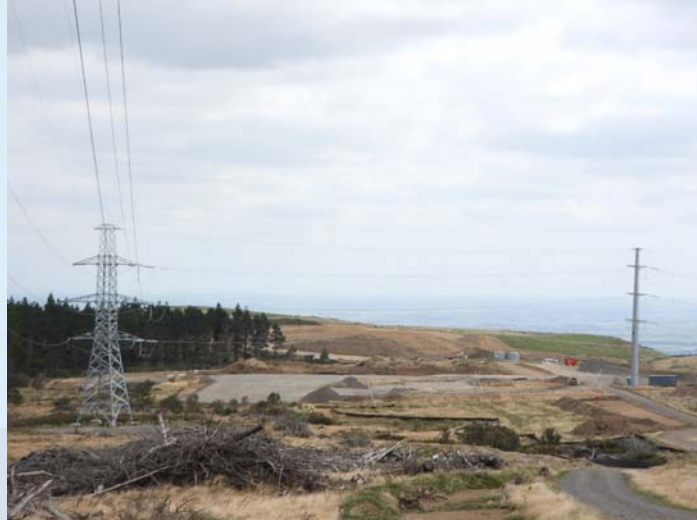
4

Glen shared this image showing preparations at the site of the new sub-station to be built in the southern zone of the site. Piling is complete at the Browns Flat substation and the contractors are establishing and beginning works there now.

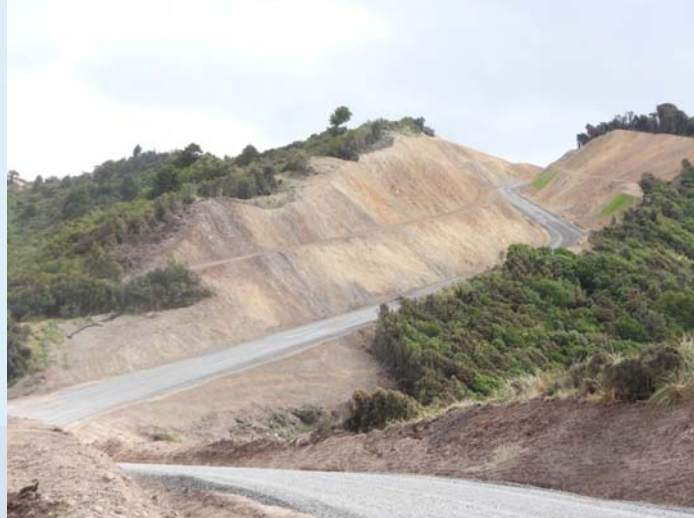
5

Glen shared this image showing the extent of works on the Reserve Road to enable access. Roading works into the South wind farm are well advanced allowing materials to arrive from the north.

Reserve Road construction earthworks are complete and tidy-up works including permanent drainage works are being completed when conditions allow.

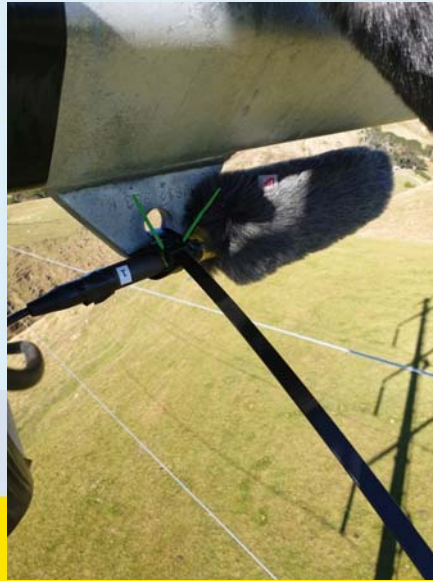
8

Picture on right shows a directional microphone on the cross arm directed at the insulator, that we suspect might be the cause of the noise.

Duncan explained that audio equipment has now been installed to discover the source of the noise.

Separately we are looking to artificially induce wind conditions on insulators, by testing them in a wind tunnel in a Wellington laboratory. If we are able to replicate the noise, we can then consider potentially fixing rubber gromets on existing insulators or replace glass with composite insulators.

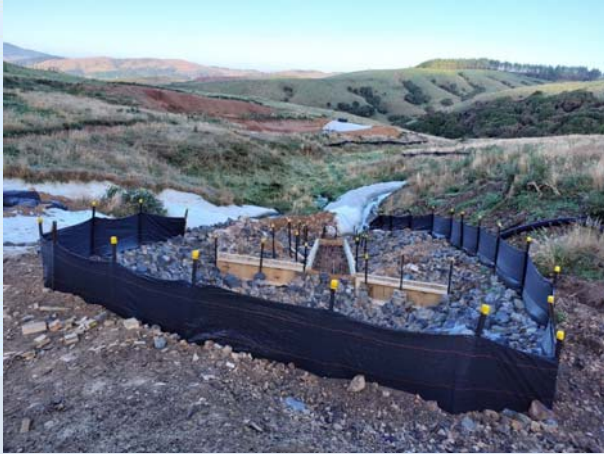
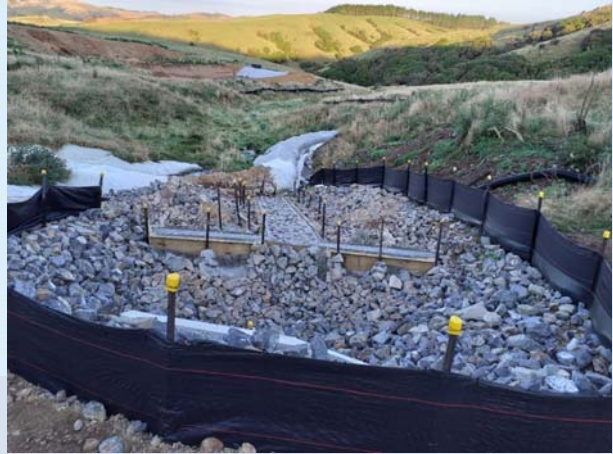
10

The picture shows the installation of a culvert complete with fish passage, boxed up and ready for concrete. This had been carefully designed with the appropriate gradient to allow fish to move as they would have naturally. Earlier, Willem Venter and the team had relocated koura from this site.

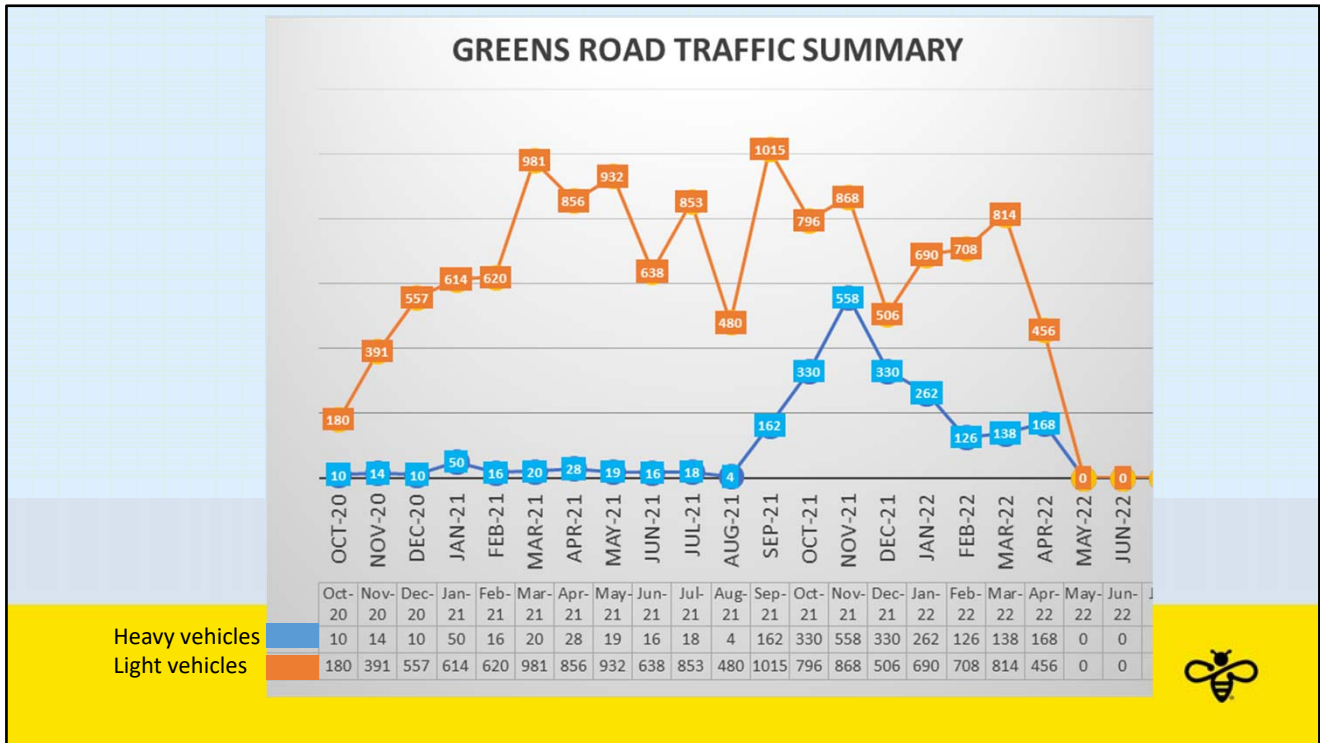
Mark shared this chart showing the ongoing count of truck movement numbers on Greens Road. Heavy and light vehicles are tracked and reported. Willem Venter sends this to the Council each month.

This is the latest monthly traffic summary for Greens Road to the southern site entrance (to end of April).

It was confirmed that around 30% of the traffic movements allowed under the Consent were still available (including the count used by Electrix for its earlier construction of the transmission infrastructure), and while large components would all be transported via the northern entrance, the traffic movements on Greens Road would be used on the substation build.
